Contract #: 04-0120F4Cty: SF/ALA Rte: 80 PM: 13.2/13.9File #: 16.28**WELDING INSPECTION REPORT****Resident Engineer:** Casey, William**Address:** 333 Burma Road**City:** Oakland, CA 94607**Report No:** WIR-029746**Date Inspected:** 22-Jun-2013**Project Name:** SAS Superstructure**OSM Arrival Time:** 730**Prime Contractor:** American Bridge/Fluor Enterprises, a JV**OSM Departure Time:** 1600**Contractor:** XKT/NESCO, Vallejo, Ca.**Location:** Vallejo, CA**CWI Name:** Wayne Van Dewark**CWI Present:** Yes No**Inspected CWI report:** Yes No N/A**Rod Oven in Use:** Yes No N/A**Electrode to specification:** Yes No N/A**Weld Procedures Followed:** Yes No N/A**Qualified Welders:** Yes No N/A**Verified Joint Fit-up:** Yes No N/A**Approved Drawings:** Yes No N/A**Approved WPS:** Yes No N/A**Delayed / Cancelled:** Yes No N/A**Bridge No:** 34-0006**Component:** Crossbeam Retro-Fit Angle**Summary of Items Observed:**

Crossbeam Retrofit Angle:

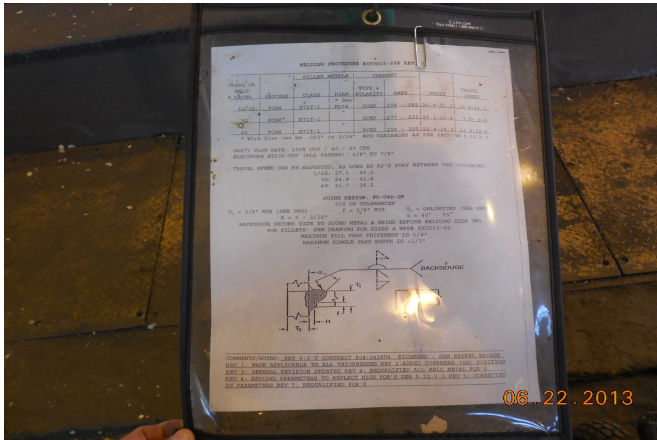
WPS available at weld station.

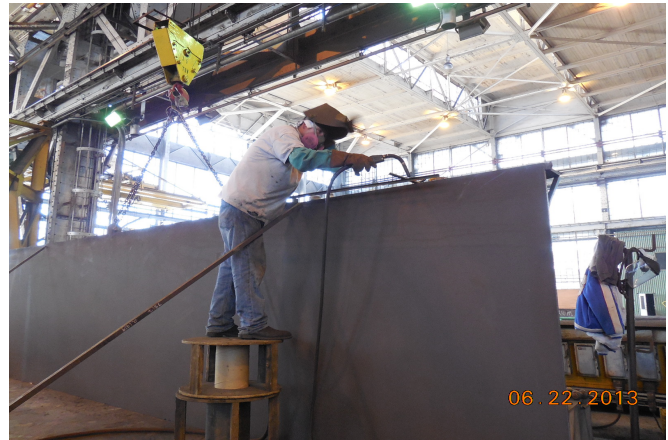
Corner CJP welded with FCAW.
